EXPERT KNOWLEDGE **TEST PROCEDURES** **OF ELASTOMER COMPONENTS**

Integral Approach in Evaluating Elastomer Seal Damage Patterns – The Best Way to the Real Cause of Failure

O-Ring Prüflabor Richter GmbH,
Dipl.-Ing. Bernhard Richter

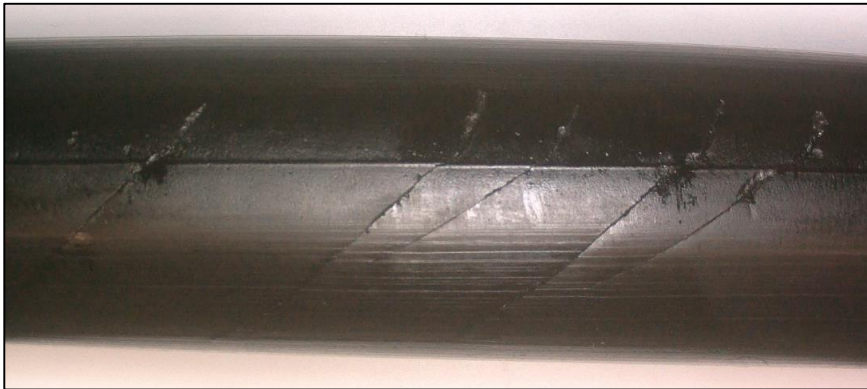
| 3. Evaluation of the Damage Pattern | cracks, conspicuous fracture surface, see pictures 2 and 3, cracks appear inside, explosive overheating |

Figure 2: Example 1 - Cracks on the outer diameter

| 5. Remedial Measures | avoidance of cyclic loading, check of start-up process, inspection of oil |

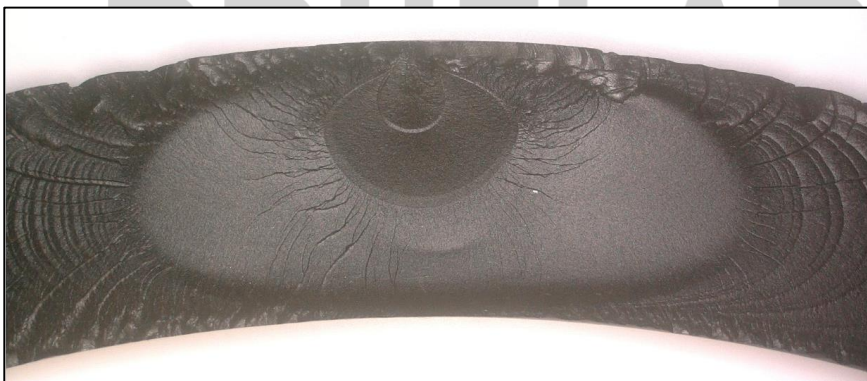
Figure 3: Example 1 - Fracture surface

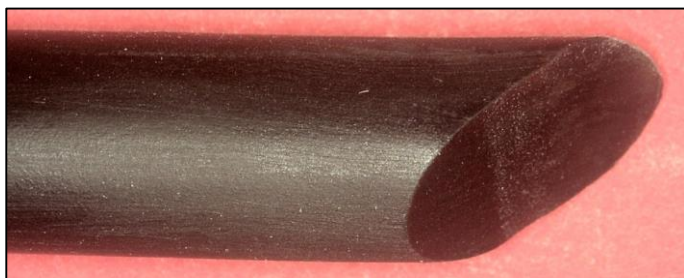
| 3. Evaluation of the Damage Pattern | Crack at the adhesive joint, see Figs. 4 and 5, with supposedly little thermally loaded O-rings near the joint crack, see Fig. 6 , assumption of thermal damage, no quality problem with the joint |

Figure 4: Example 2 - Torn joint

| 5. Remedial Measures | Find cause for overheating, better use endless vulcanized O-rings with better temperature resistance |

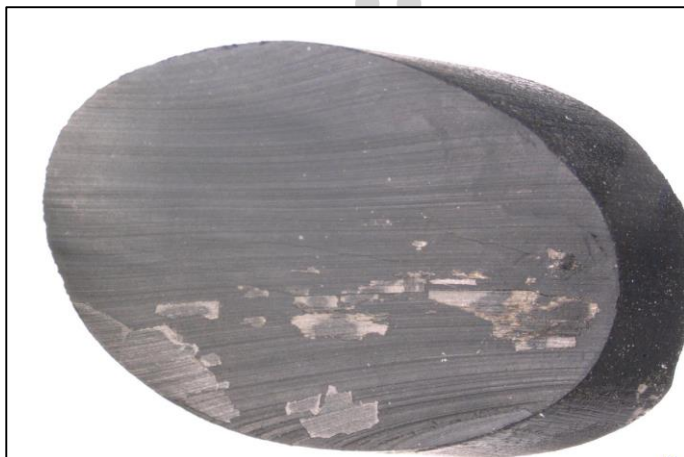
Figure 5: Adhesive residues (acrylate adhesive) at the butt joint

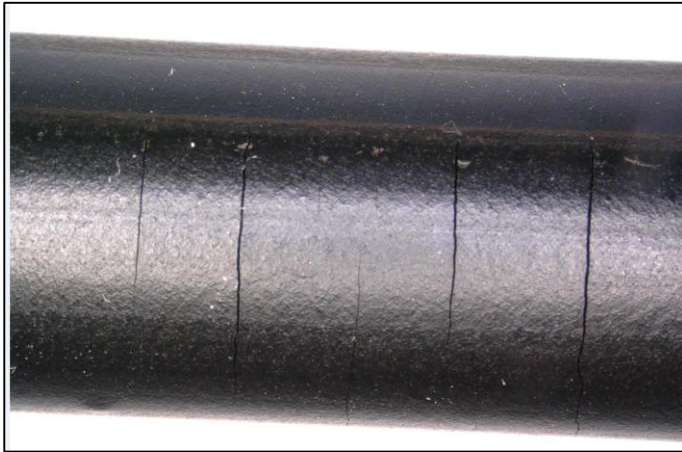
Figure 6: Cracks during bending at the O-ring with the supposedly lower thermal load

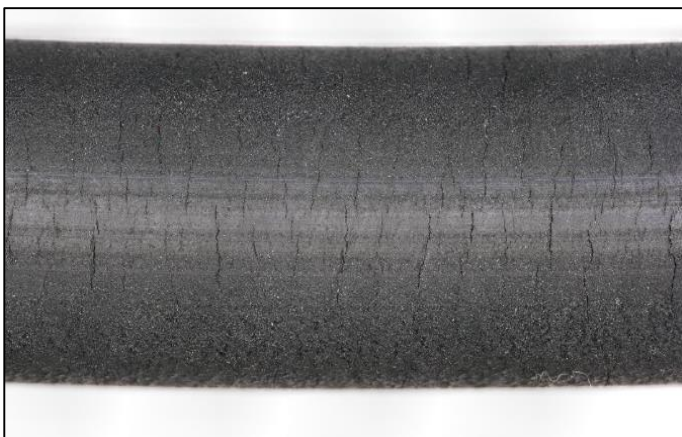
| 3. Evaluation of the Damage Pattern | Directed cracks, see Fig. 7 , the profile section shows that the cracks are formed on the outside, which means they are not caused by the pumped medium on the inside, see Fig. 8 . The damage pattern is typical for ozone cracks |

Figure 7: Example 3 - Cracked NBR fuel hose

| 5. Remedial Measures | Conversion to new formulation (and new supplier), repetition of ozone test, no cracks in results, see Fig. 10 |

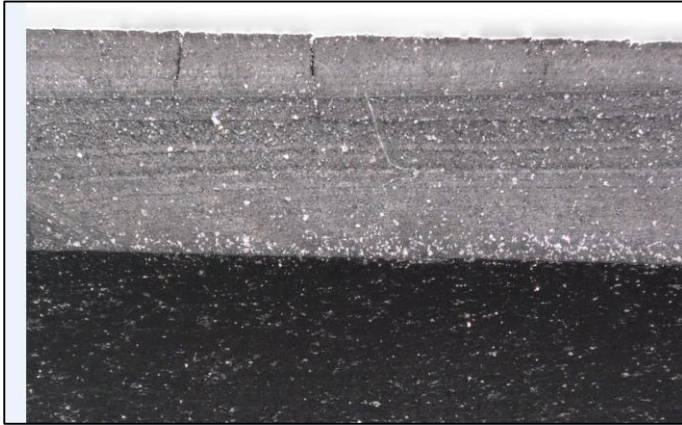
Figure 8: Example 3 - Profile section of the hose wall

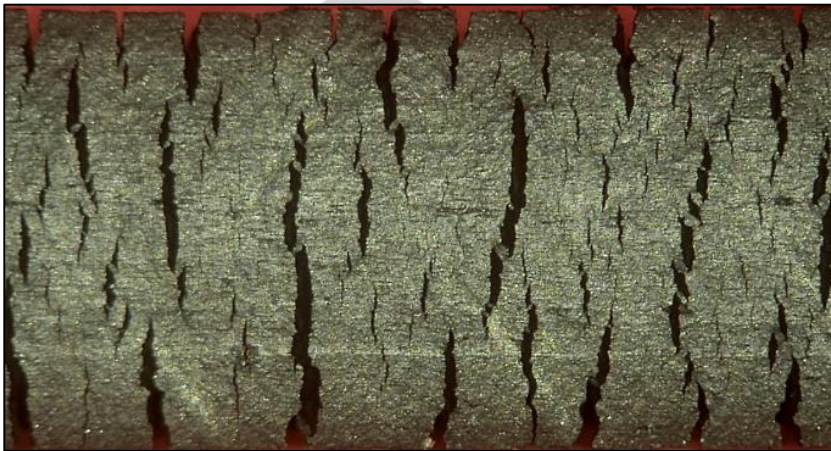
| 4. Assurance of the Assumptions | Ozone test 48h/23°C/20% elongation 50pphm Ozone on new reference part, result strong cracks, see Fig. 9 |

Figure 9: Example 3 - Current series sample after ozone test

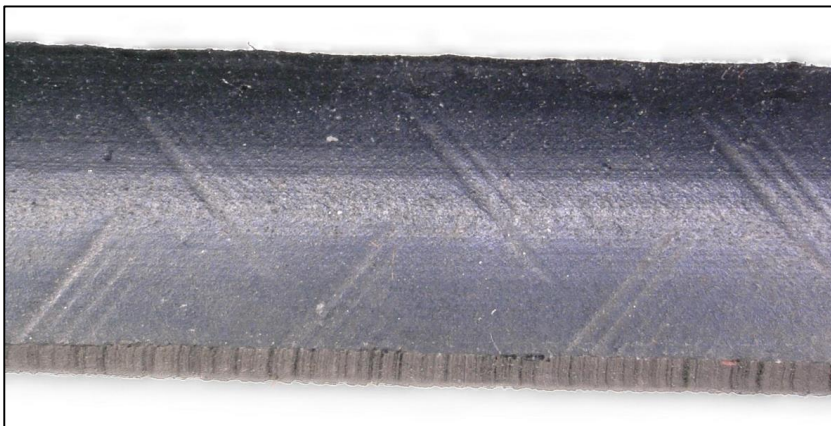
Figure 10: Example 3 - New material (new supplier) after ozone test
