FAILURE ANALYSIS

OF ELASTOMER COMPONENTS

Cracks as a Result of Manufacturing Problems – A Severe Fault that Often Leads to Seal Failure

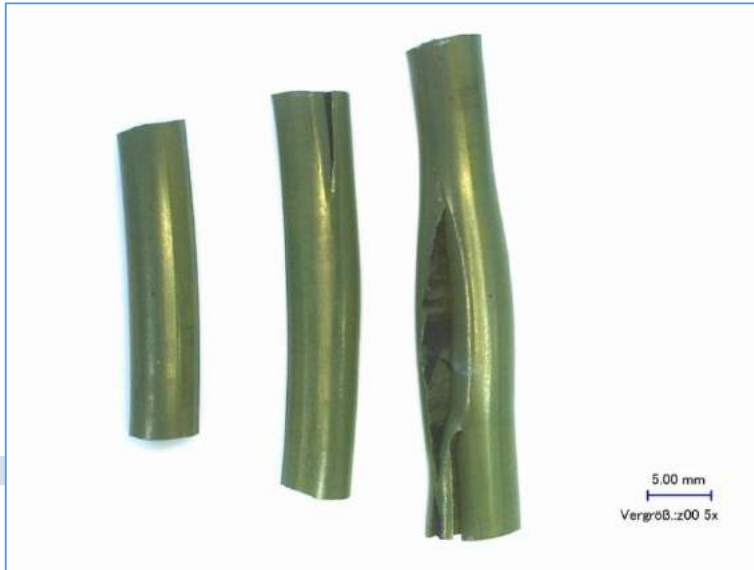
There are polymers, such as ACM materials, which are particularly sensitive to temperature control, but if production parameters are not optimal, cracks can also occur in all other elastomers due to vulcanization defects: If vulcanization is to be accelerated too much by high temperatures, any compound can vulcanize too early. In the application, this may only reveal itself under deformation and high temperatures (see **Fig. 1**).

Fig. 1: Cracks in an FKM O-ring due to over-vulcanization after a compression set test of 168h / 200°C

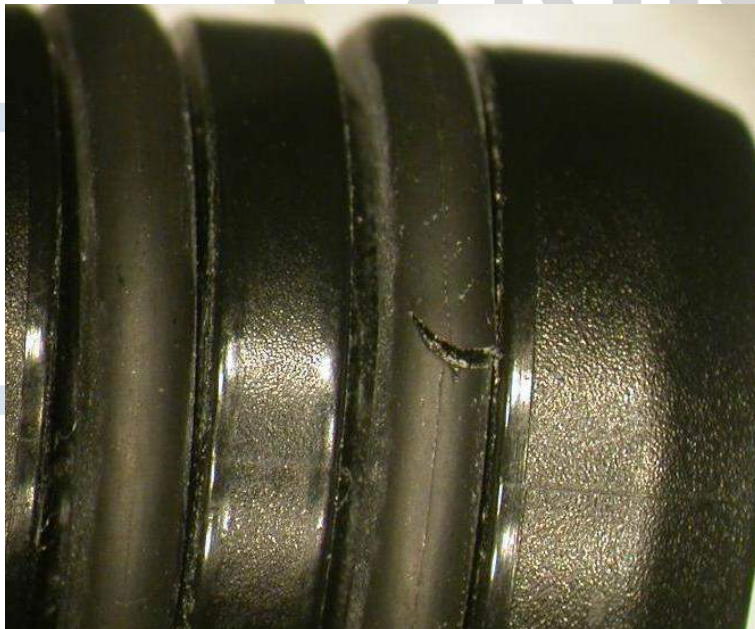
Cracks caused by flow lines are often parabolic and symmetrical to the mold parting line (see **Figs. 2 to 4**). In the case of faulty vulcanization, an inhomogeneous fracture point usually appears in the area of the fracture point (see **Figs. 5 and 6**), sometimes there are also conspicuously smooth areas in the fracture surface. Typical for cracks caused by vulcanization defects is also a rounded transition from the surface to the crack (see **Fig. 7**) compared to a case of damage caused by a cut

Fig. 2: Crack due to a vulcanization defect, recognizable by the parabolic crack shape symmetrical to the mold parting line

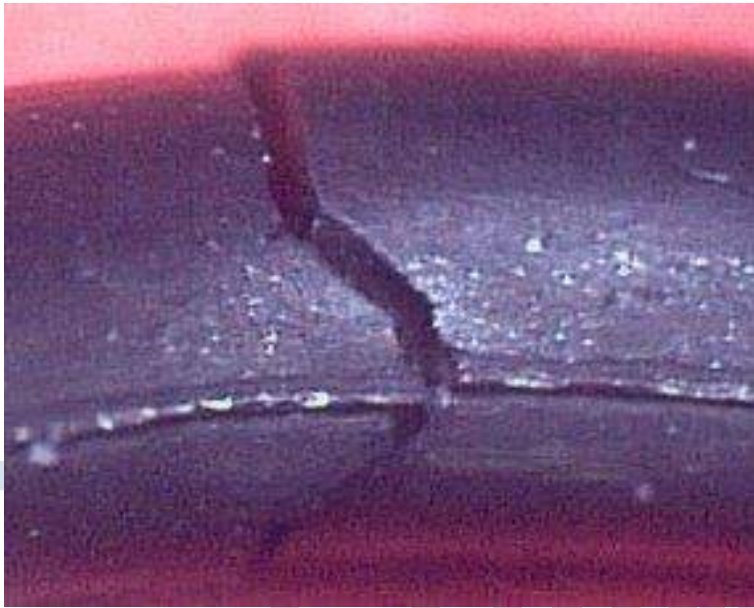
Fig. 3: Manufacturing crack, parabolic and symmetrical to the mold parting line

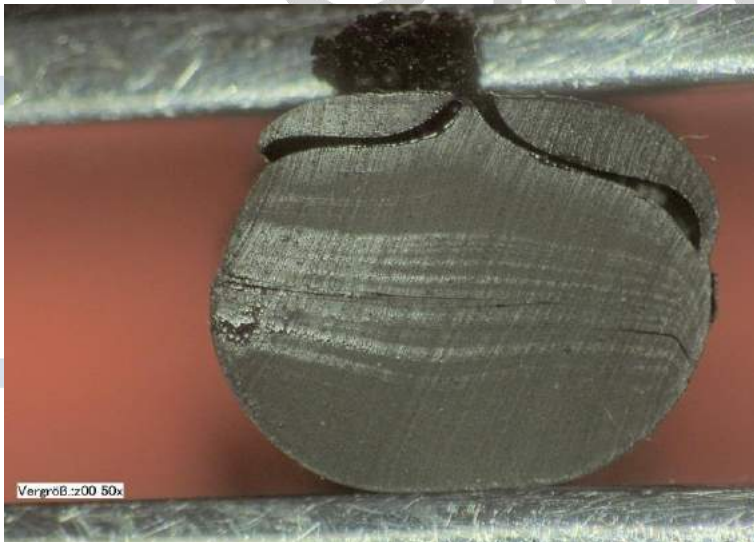
Fig. 4: Cracks due to a superimposed elastomer compound

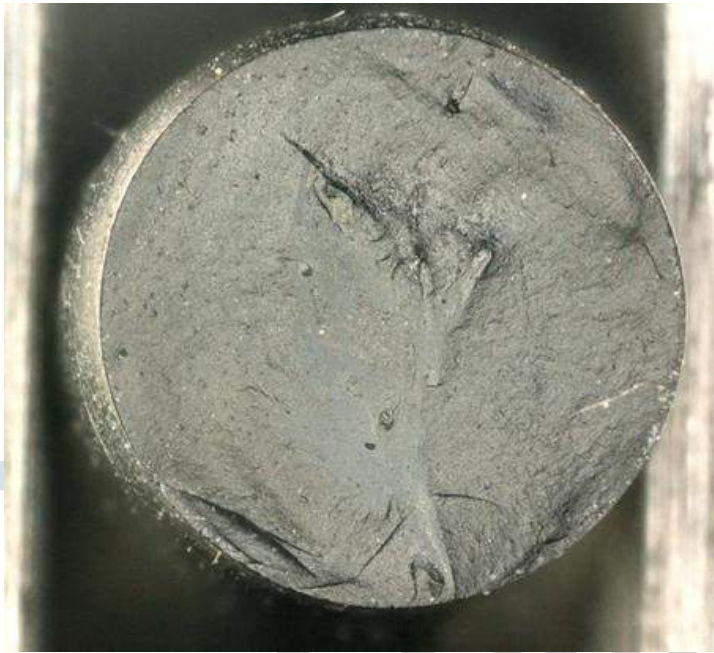
Fig. 5: Torn O-ring caused by a vulcanization error

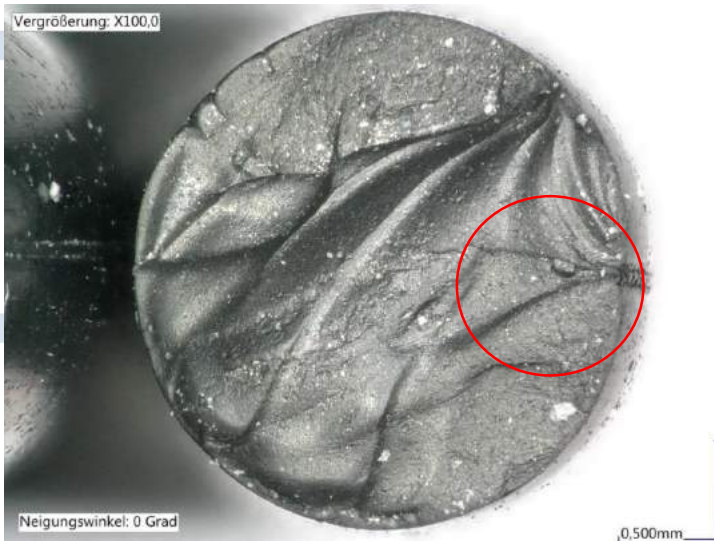
Fig. 6: Torn O-ring due to vulcanization defect: Inhomogeneous, fissured fracture surface

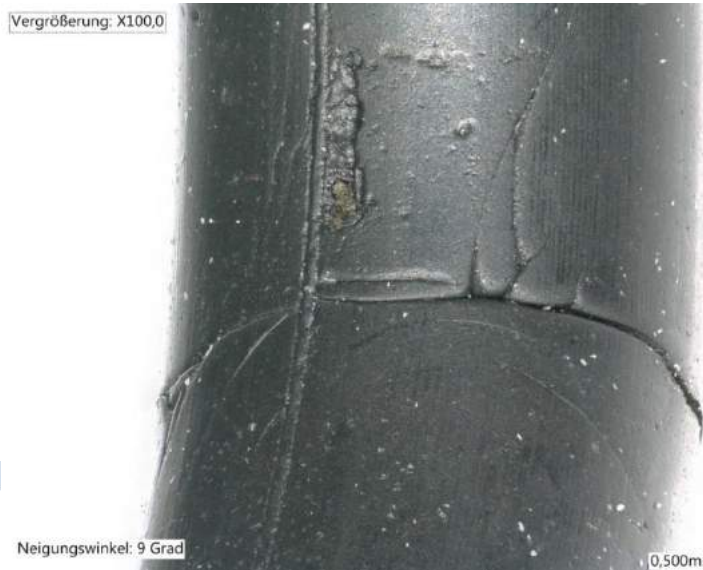
Fig. 7: Vulcanization defects due to production: Rounded crack transition (same O-ring as in Fig. 4)

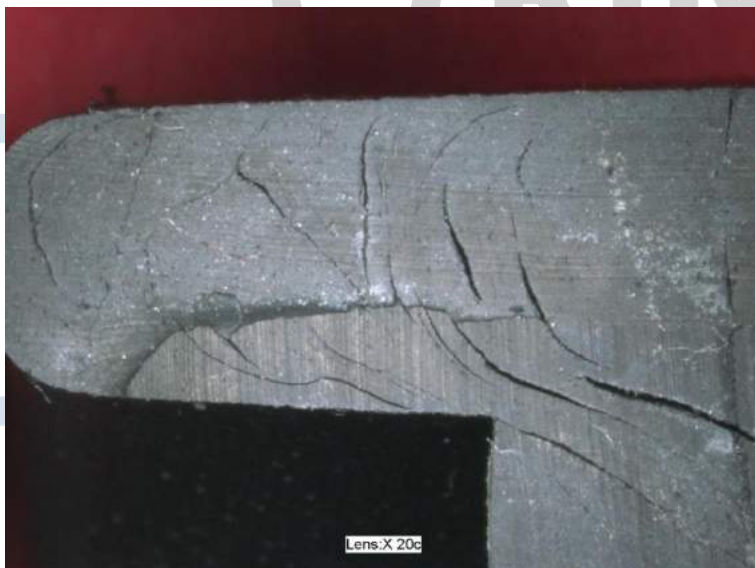
Fig. 8: Production-related cracks due to a superimposed compound

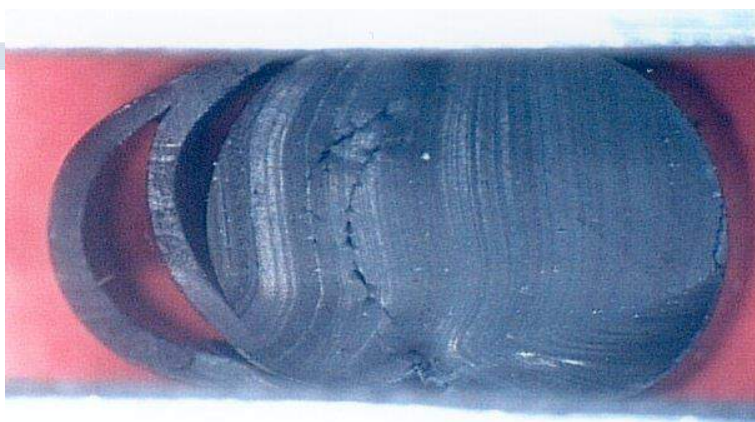
Fig. 9: Cracks or peeling on an O-ring due to faulty vulcanization (cause: superimposed compound)

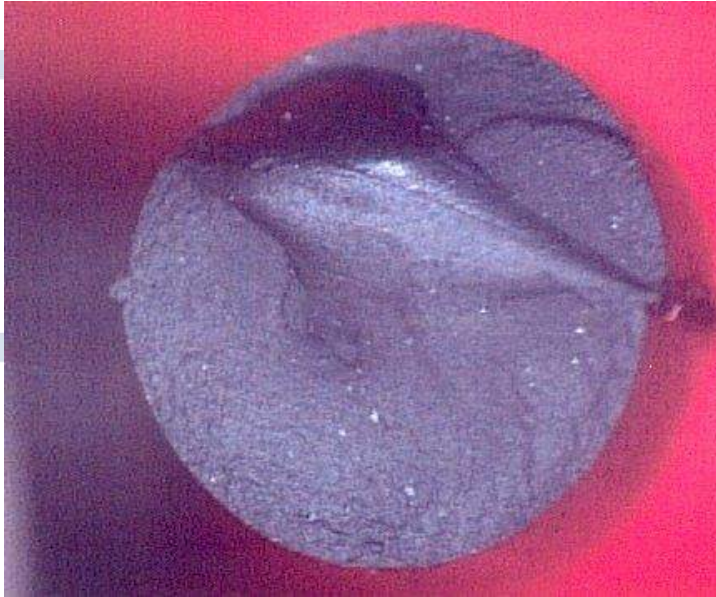
If foreign particles are detected on a cracked seal in the area of the fracture surface with a microscope, they can be the trigger for the crack (see **Figs. 10 and 11**). Today, the FT-IR microscope and/or the REM-EDX analysis are available for a more in-depth analysis of the foreign material.

Fig. 10: Manufacturing crack due to foreign material (mold release agent)

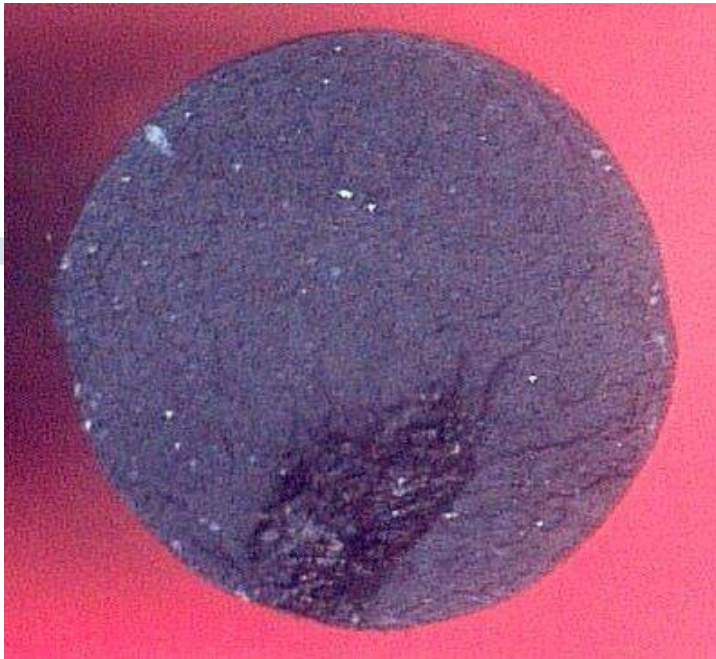
Fig. 11: Crack triggered by foreign material entry

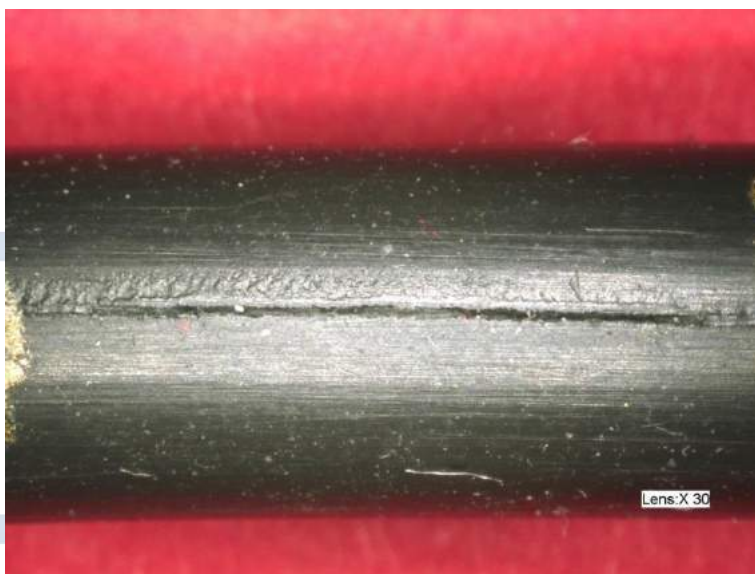
This type of crack starts at the parting plane (see **Figs. 12 and 13**). Often in the cross section of an O-ring a circumferential entry point with a wide "U" or "W"-shaped cross section (see **Fig. 14**) can be seen. The draw-in point is a flat, plate-shaped depression, sometimes triangular in section at the parting line at the inner and/or outer diameter. This is caused by damage of the tool edge and/or the high shrinkage factor of rubber.

Fig. 12: Shrinkage crack on an O-ring

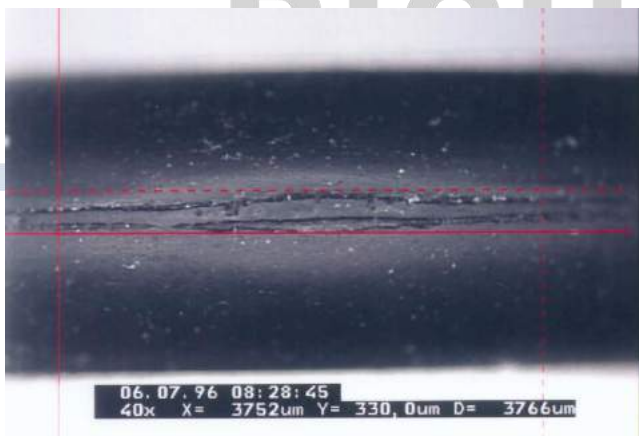
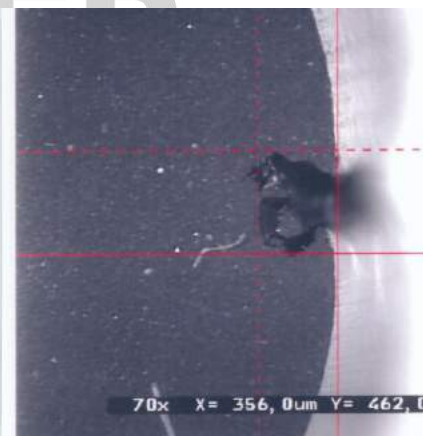
Figs. 13 and 14: Shrinkage cracks at the tool parting plane of an O-ring and on the right in a cross-cut O-ring

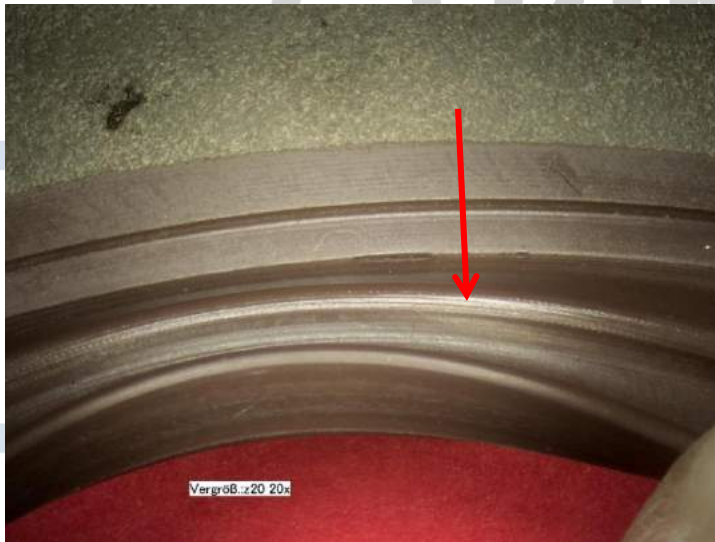
These often occur at sharp transitions, edges (see **Fig. 15**) or undercuts (see **Fig. 16**). In addition, an excessively high demolding temperature can favor this.

Fig. 15: Demolding crack on a molded gasket

Production problems can already be reduced or avoided in advance through rubber-compatible component design. For example, edges on the molded gasket, where demolding cracks can occur regularly, should be structurally defused (e.g. by radius, avoidance of undercuts).

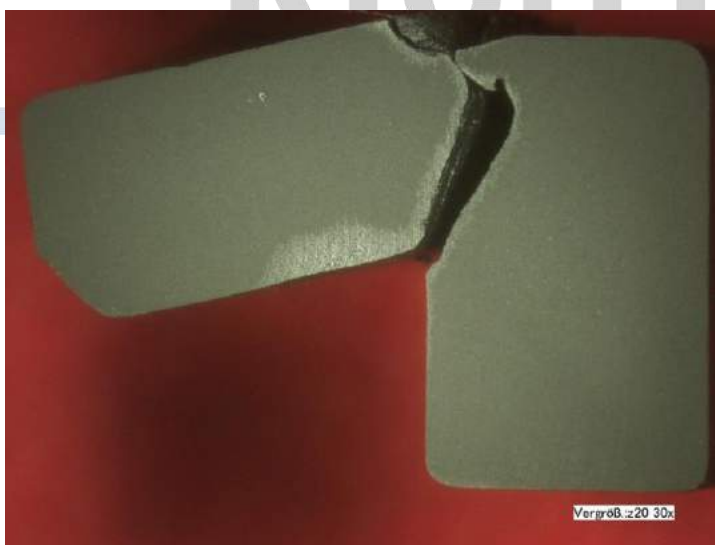
Fig. 16: Demolding crack at a sealing element

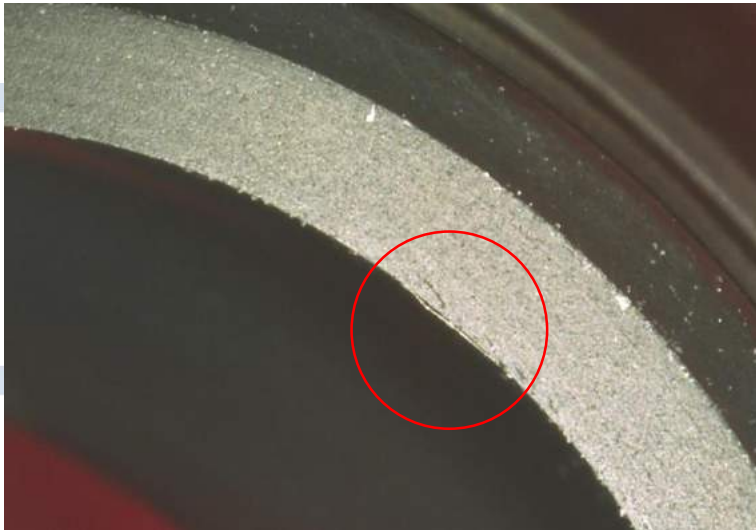
This damage pattern shows damage or cracks in the area of the post-processed surface (see **Figs. 17** and **18**). If the machining method and tool are known, the cause of the damage can be determined even more reliably.

Fig. 17: Cracking caused by the finishing step "cutting off the sealing edge"

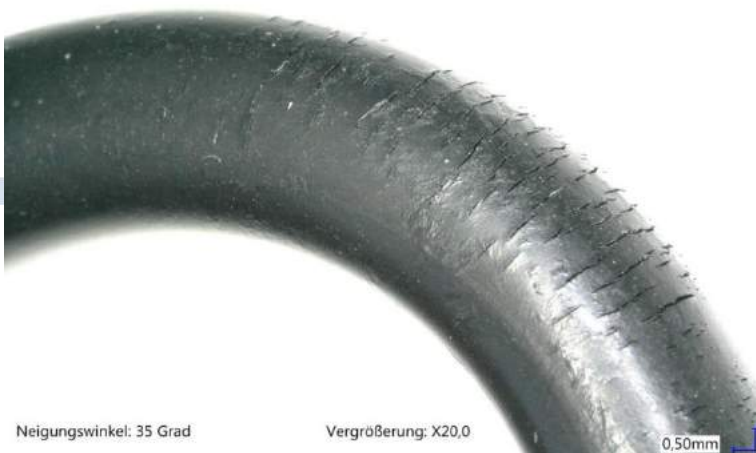
Fig. 18: Cracks caused by the post-processing step "post-curing" (local overheating due to defective or incorrectly set tempering furnace)

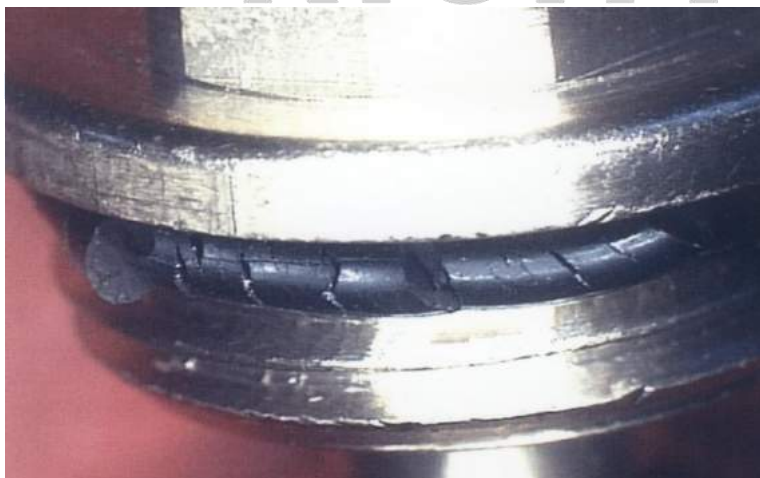
Fig. 19: Pre-assembled O-ring, which showed ozone cracks after several weeks due to the pre-stressing and ozone from the ambient air.

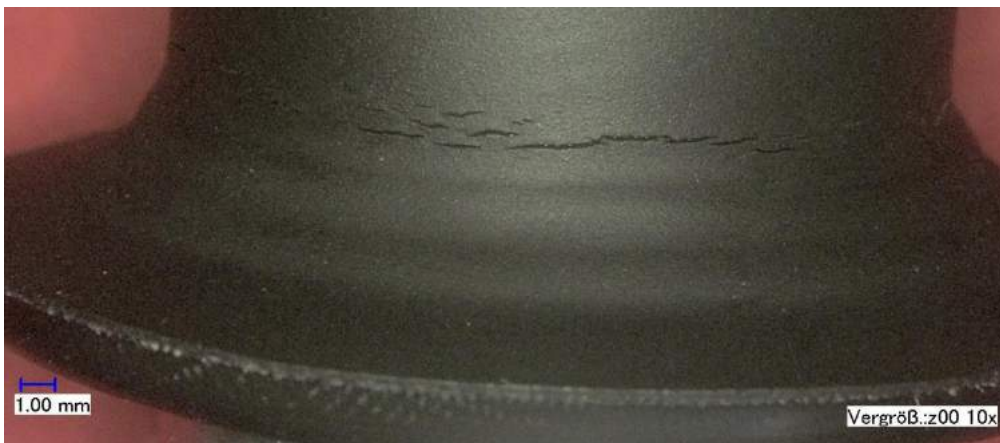
Fatigue cracks (see **Fig. 20**) are very similar to ozone cracks. A clear differentiation is usually only possible if the stress that led to the damage is known. If a failed seal is not made of a diene rubber (e.g. FKM), but shows damage similar to ozone cracks, an immediate exclusion of ozone cracks as cause of damage is possible.

Fig. 20: Fatigue cracks on an FKM membrane

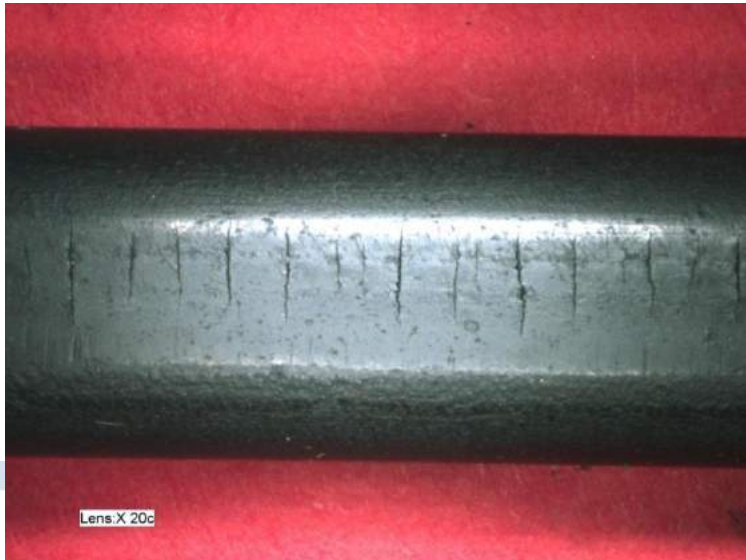
"In the event of thermal overloading over long periods of time, the O-ring or seal becomes brittle over the entire cross-section (see **Fig. 21**). When bending, the cracks appear preferably on the air side or on the sealing surfaces where the heat was supplied (see **Fig. 22**).

Fig. 21: Thermally damaged O-ring, fully hardened, cracks visible on the contact surfaces when bending

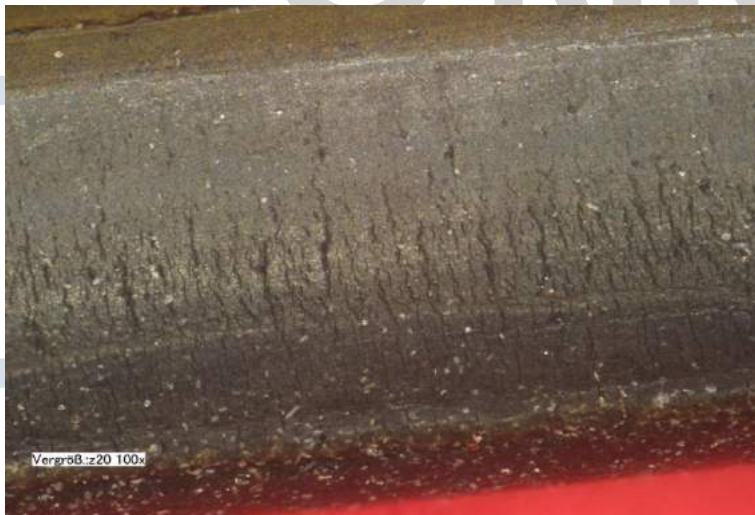
Fig. 22: Cracks due to aging due to heat and oxygen under slight elongation can be seen on the contact surface of an O-ring

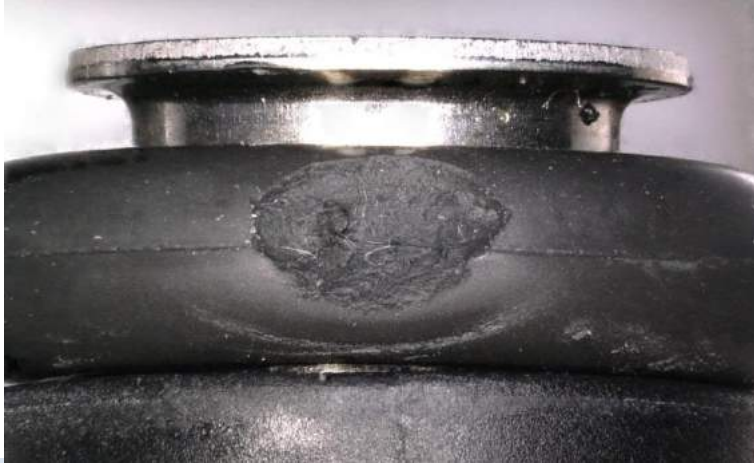
Fig. 23: Chipping out during assembly: The damage occurred at room temperature and resulted in a non-smooth fracture surface; the characteristics of the fracture surface are also strongly dependent on the tear resistance of a material.

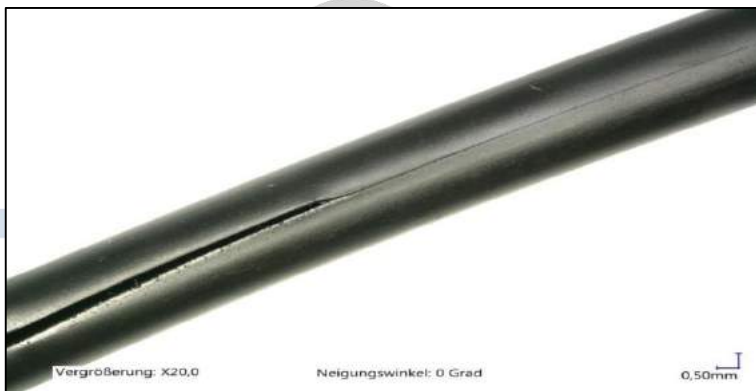
Fig. 24: Installation crack due to the impact of a sharp edge in the installation space

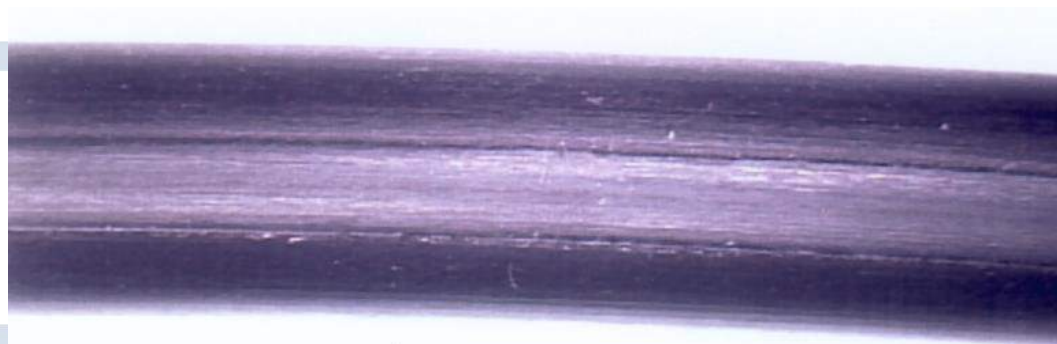
Fig. 25: Crack caused by a sharp edge during installation

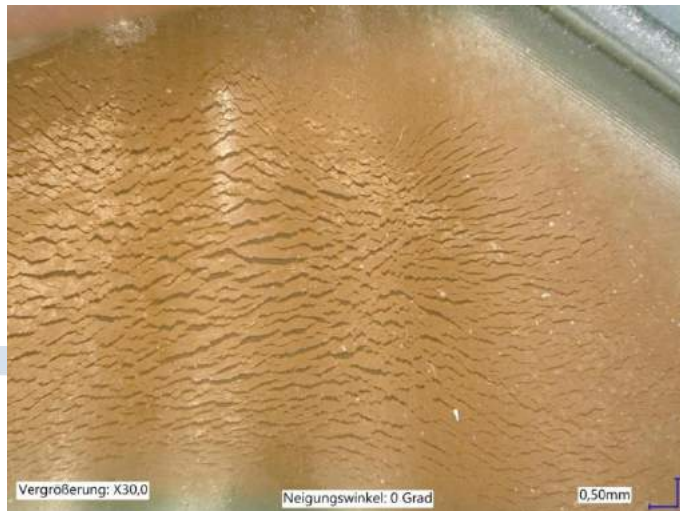
A chemical degradation can cause cracks to appear, but not necessarily. The cracks are visible on the side of the impacting medium and can sometimes only be seen after stretching and under the microscope. If side-effects such as strong setting behavior, sticky surface or hardening occur, the probability of a chemical degradation increases considerably. Chemically induced cracks, however, usually only occur after rather long operating times (>1000 operating hours), with the cracks usually covering larger areas (see **Fig. 26**), whereas in the case of

Fig. 26: Chemical degradation of an FVMQ membrane: The cracks cover a larger area.
