EXPERT KNOWLEDGE FAILURE ANALYSIS OF ELASTOMER COMPONENTS

Excessive Abrasion **The Elastomer Seal: A Soft Partner in a Hard Environment**

1. Classification and Frequency of the Damage Pattern

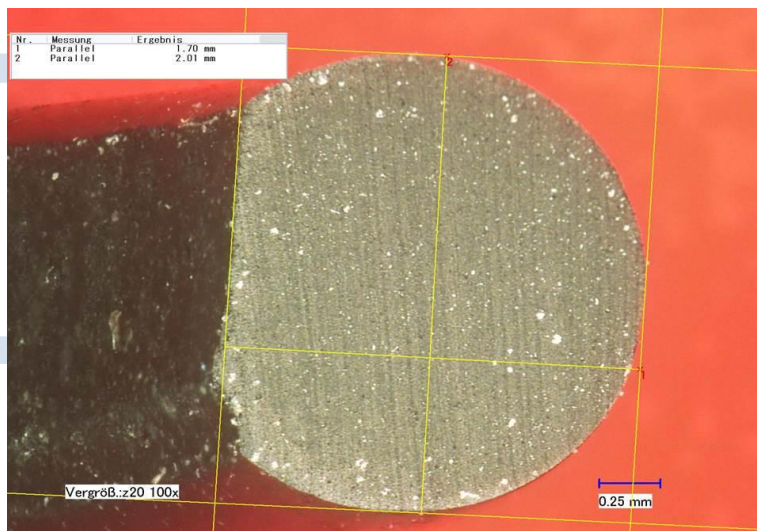
3.1.1 Damage Pattern "Abrasion due to unsuitable mating surface"

Fig. 1: Excessive abrasion caused by a poor mating surface

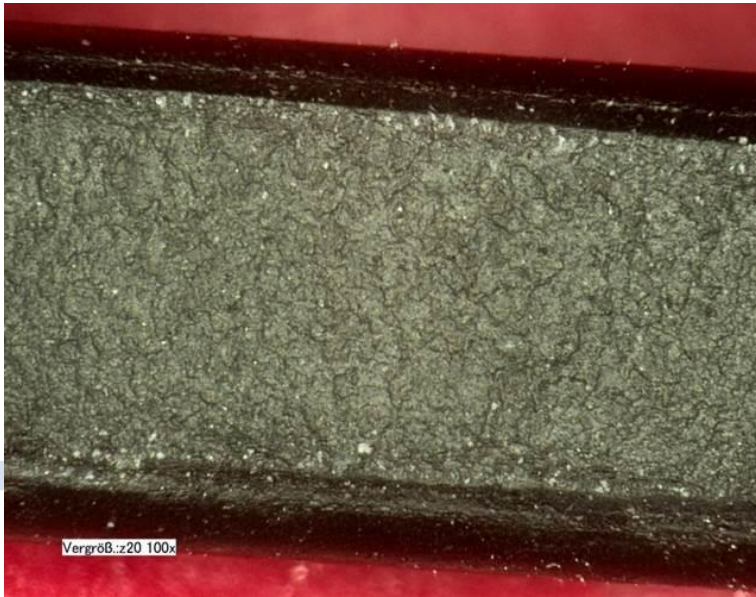
Fig. 2: Frontal view of the abraded area of the O-ring from Fig. 1

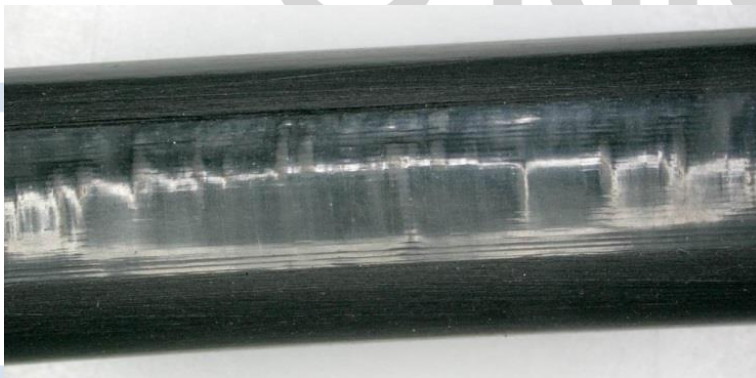
Fig. 3: Unsymmetrically flattened O-ring, the abraded surface is smooth and shiny.

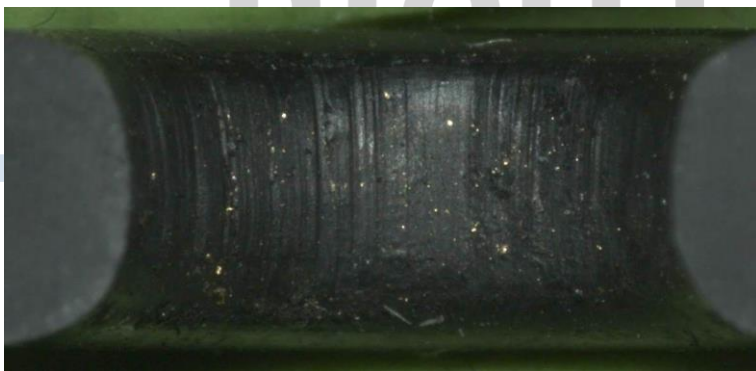
3.1.2 Damage Pattern "Hydroabrasion"

Fig. 4: Inside of a cut EPDM O-ring from a thermostatic valve: Metal particles are clearly visible in the grooves (hydroabrasion).

An important preventive measure against hydro-abrasion is regular oil maintenance and the use of suitable filters to keep the particle load in the oil as low as possible.

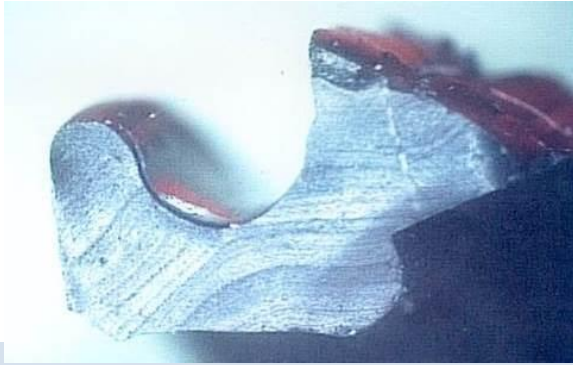
3.1.3 Damage Pattern "Abrasion due to inadequate lubrication / dry running"

Fig. 5: Heavy abrasion on the sealing lip of a radial shaft seal after dry running or deficiency lubrication and impermissibly high pressure loading

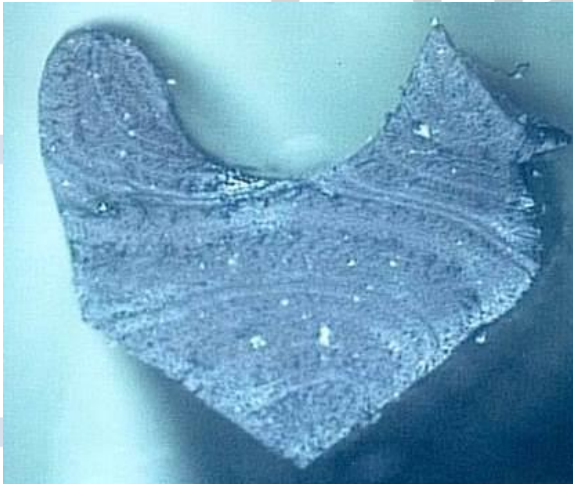
Fig. 6: Original profile of the radial shaft seal from Fig. 5

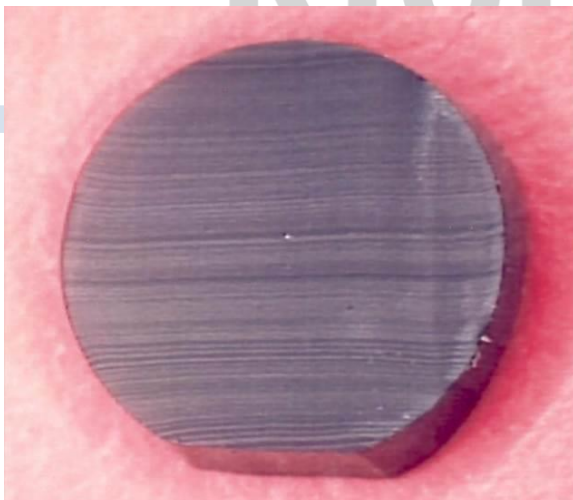
3.1.4 Damage Pattern "Abrasion due to constructional defects"

Fig. 7: One-sided flattened O-ring; the abraded surface itself is smooth and glossy. In order to keep friction forces low, dynamically used O-rings are often pressed only slightly. As a result, relatively low abrasion, as on the O-ring shown, leads already to leakage.

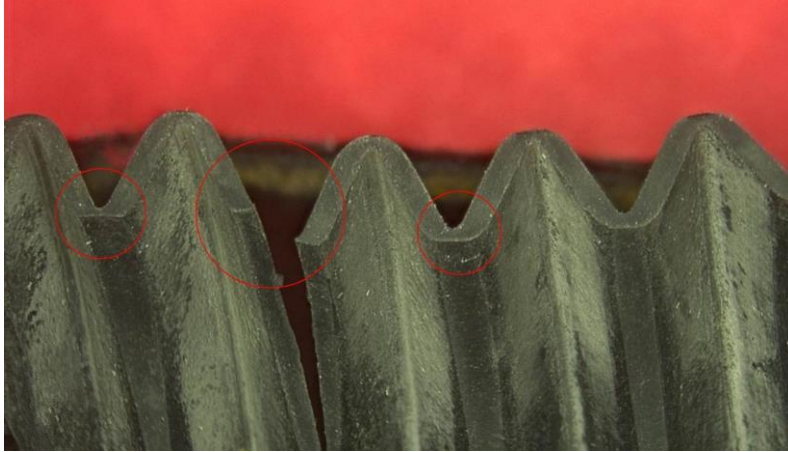
Fig. 8: Rupture of an EPDM bellows due to abrasion (middle red circle), the left red circle shows a heavily abraded area, which is also shortly before the rupture. This damage can be avoided by reinforcing the material in the critical area or by changing the design to reduce chafing.

However, abrasion can also cause ruptures in rubber components, e.g. bellows, if, for example, thin areas are heavily abraded.

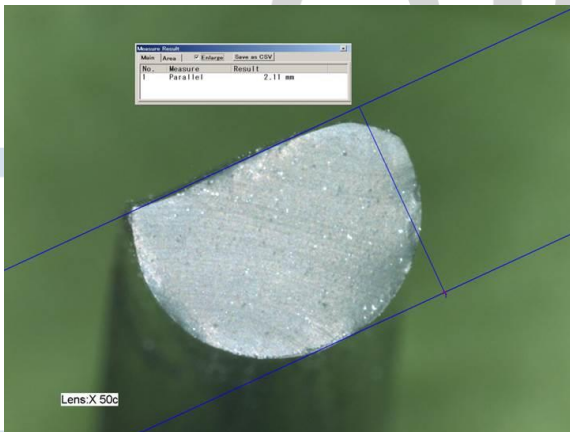
In the event of hard pressure surges in hydraulic systems, seals used statically can also experience abrasion. If the seal bushing has too much axial play, this can lead to considerable abrasion wear due to cyclic loading, despite the short frictional travel of the seal or the O-ring (a few tenths of a millimeter).

3.1.5 Schadensbild „Abrieb durch übermäßige druckbedingte Axialhübe“

Fig. 9: Abrasive O-ring (EPDM, 70 ShA) made of "static" seal with excessive axial stroke due to pressure; Piston installation space: Piston fixed with steel clamp, yielded 0.5-1 mm under pressure (10 bar), diameter play approx. 0.5 mm, eccentric position

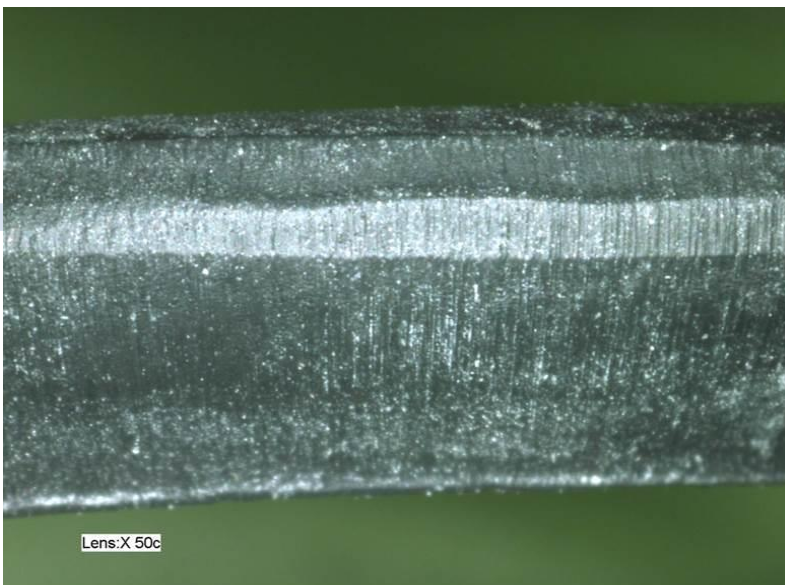
Fig. 10: Top view outside diameter of the damaged O-ring from Fig. 7
