EXPERT KNOWLEDGE FAILURE ANALYSIS OF ELASTOMER COMPONENTS

Ozone Cracks on Elastomeric Seals and Components: A Common, But Preventable Cause of Failure

Dipl.-Ing. Bernhard Richter,
Dipl.-Ing. (FH) Ulrich Blobner

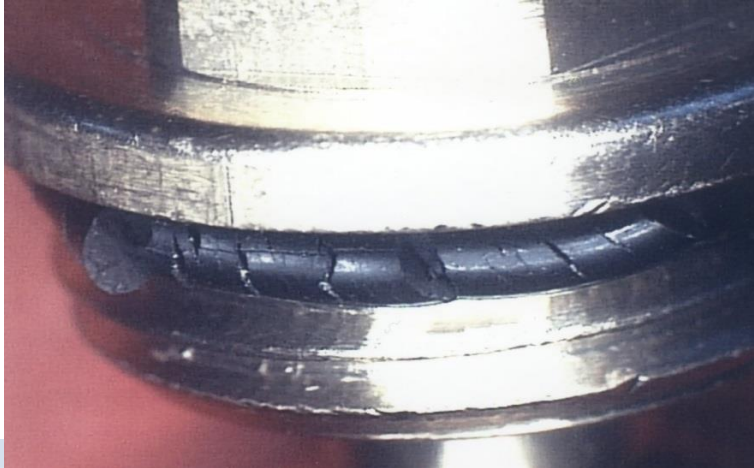
Figure 1: Pre-installed NBR O-Ring, severely cracked after several weeks of storage

Ozone cracks always develop vertical to the direction of stress. Cracks are deep and can lead to the tearing of the seal. The damage is irreversible and can only be rectified by the replacement of the seal.

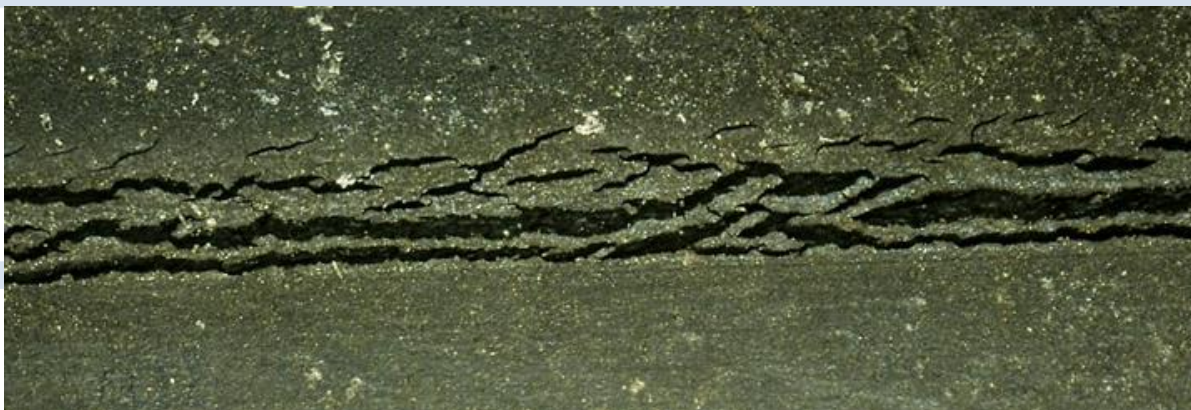
Figure 3: Cracks on a static pre-stretched bellow made of a BR/IR-elastomer

An important precondition for ozone cracks is that the seals are stressed or deformed. Deep cracks can already develop at minor stretching (e.g. 5%). When stretching increases, more cracks evolve. Due to the great depth of cracks this is usually unacceptable for the application. All unsaturated rubbers, i.e. diene rubbers that have double bonds in the main chain, are prone to the development of ozone cracks. The double bonds can be attacked by ozone. Diene rubbers can be identified by the 'R' in their short term (e.g. NBR, SBR, NR, BR,...). An exception is a fully hydrogenated HNBR that has a relatively good resistance against ozone cracks. M-, Q- and O-rubbers (like e.g. FPM, VMQ, ECO) are regarded as having good to very good ozone resistance.

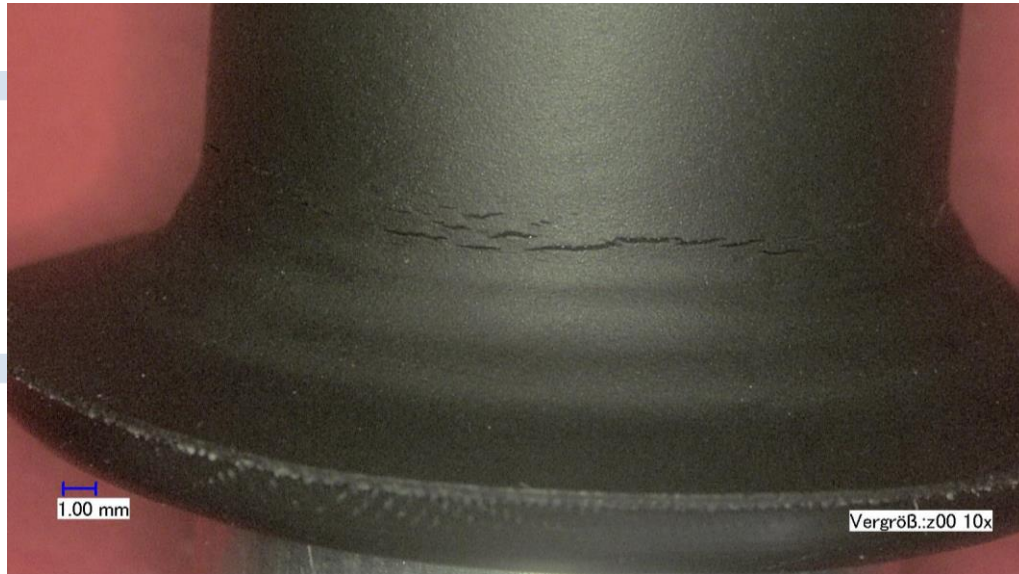
Figure 4: Fatigue cracking on FKM-membrane

The damage symptoms of ozone cracks resemble closely the damage symptoms of fatigue cracking by cyclical dynamic stress. If the history, or the kind of stress, is known, a clear differentiation is possible. The difference to chemical degradation is shown in the greater depth of cracks and in stress-dependent cracks, which appear usually in parallel alignment. Frequently, ozone cracks are found on pre-installed assemblies if they are exposed directly to ambient air during intermediate storage. Cracks can even develop after a few days.

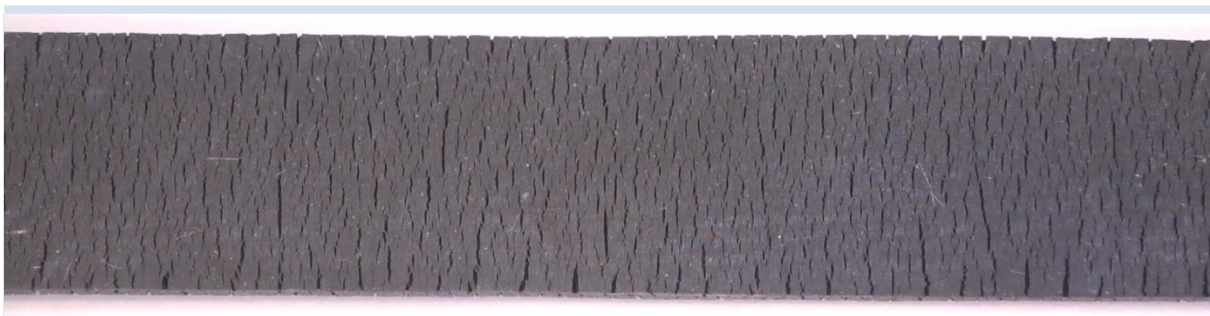
Figure 6: Example of elastomer specimen after ozone test (condition after 48h / 40°C / 20% stretching / 50 pphm ozone concentration / 55% relative humidity): Sample is still in stretched condition and has long, moderately wide cracks (stage 2 assessed based on DIN 53509) (10x magnification)

If unsaturated elastomers in deformed condition are exposed to ambient air in the application for a longer period of time, an ozone resistance test (ISO 1431) is recommended (see **Figure 6**). If possible, this test should be performed directly on the finished part to check the effectiveness of the applied ozone protection in the compound. At the Richter O-Ring Test Laboratory two ozone test cabinets are available (see **Figure 7**). The ozone test at the O-Ring Test Laboratory was accredited in 2016. Both Ozone cabinets are continually monitored by an independent ozone measuring station.

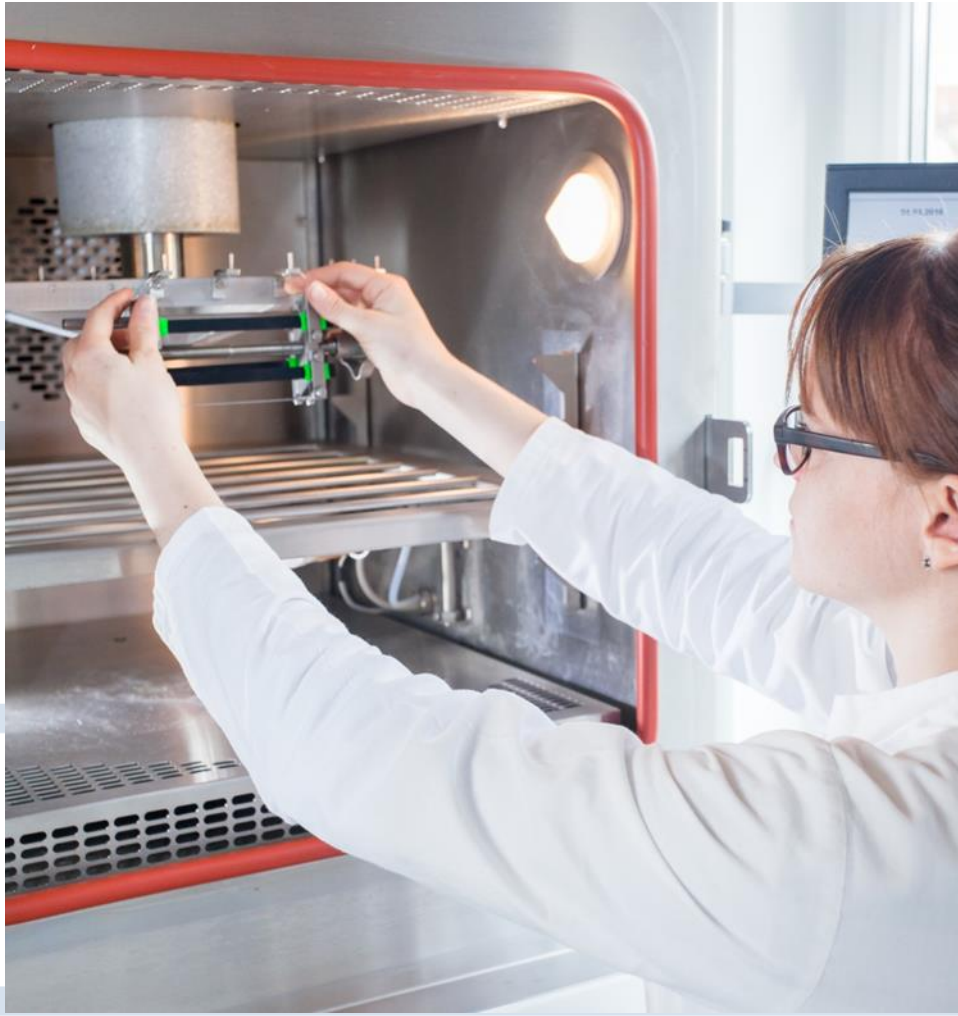
Figure 7: Performance of ozone test: Employee of Richter O-Ring Test Laboratory in front of an open ozone cabinet
