EXPERT KNOWLEDGE FAILURE ANALYSIS OF ELASTOMER COMPONENTS

Autoxidation – Rubber Poisons Can Rapidly Accelerate Elastomer Aging

Dipl.-Ing. Bernhard Richter,
Dipl.-Ing. (FH) Ulrich Blobner

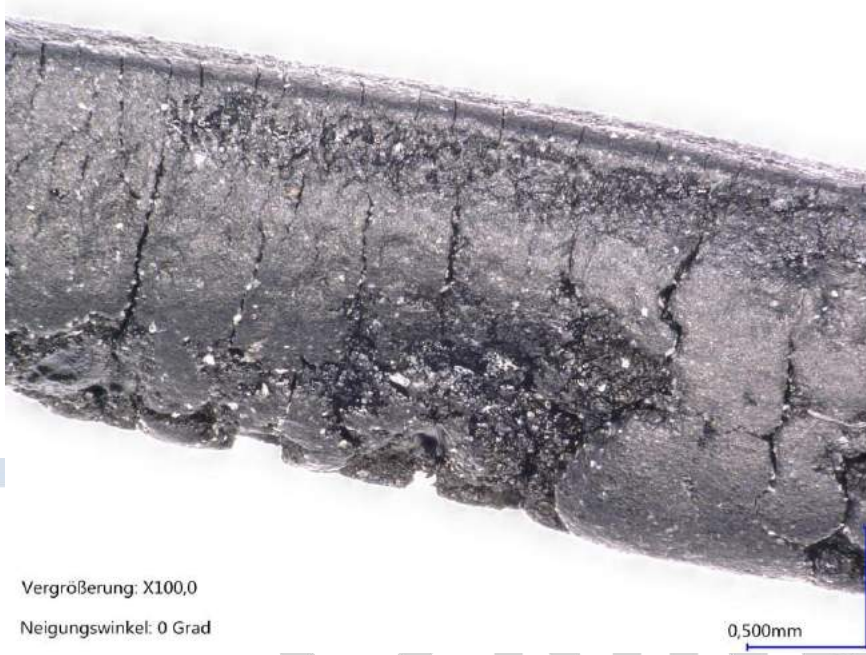
Fig. 2: EPDM O-ring, peroxidically cross-linked after use in a monitored endurance test for a water fitting (cause of damage: dezincification of brass, cyclic temperature changes from 25°C to 95°C in water, test duration 4500 h)

Damage caused by autoxidation often has a diverse appearance. Elastomeric materials can soften, crack (see **Fig. 2**), become sticky or shiny due to this mechanism. These characteristics can occur on the same gasket in different areas. In extreme cases of autoxidation, complete depolymerization of the gasket may occur, meaning decomposition to the extent of carbon black. A preliminary stage before complete depolymerization is the appearance of shiny areas, which are often accompanied by local softening. These glossy areas are reminiscent of a partially melted thermoplastic (see **Figs. 4 and 5**), although a three-dimensional elastomer cannot be melted.

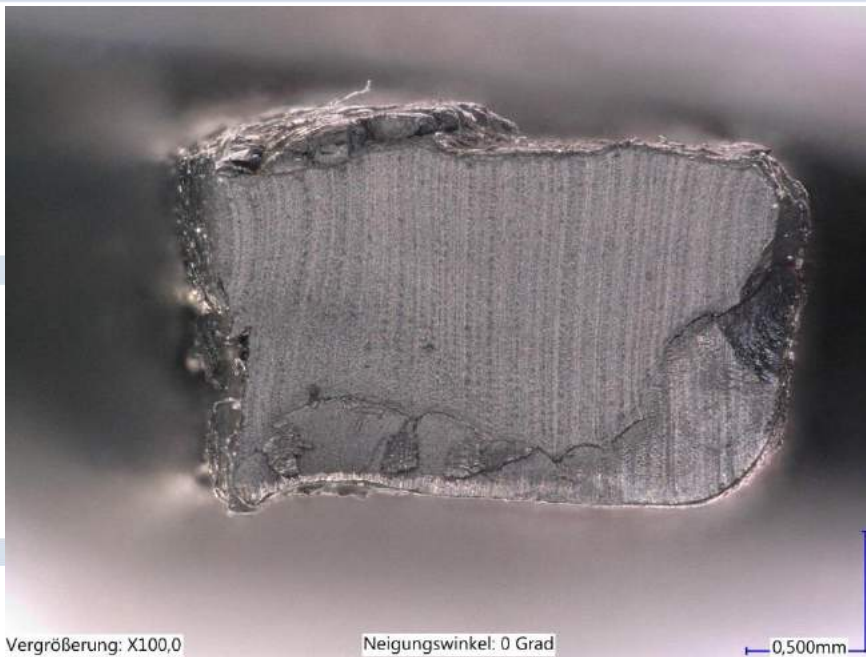
Fig. 3: Cross section of the O-ring from Fig. 2, the autoxidative damage occurred mainly in the marginal areas, the core is not yet depolymerized.

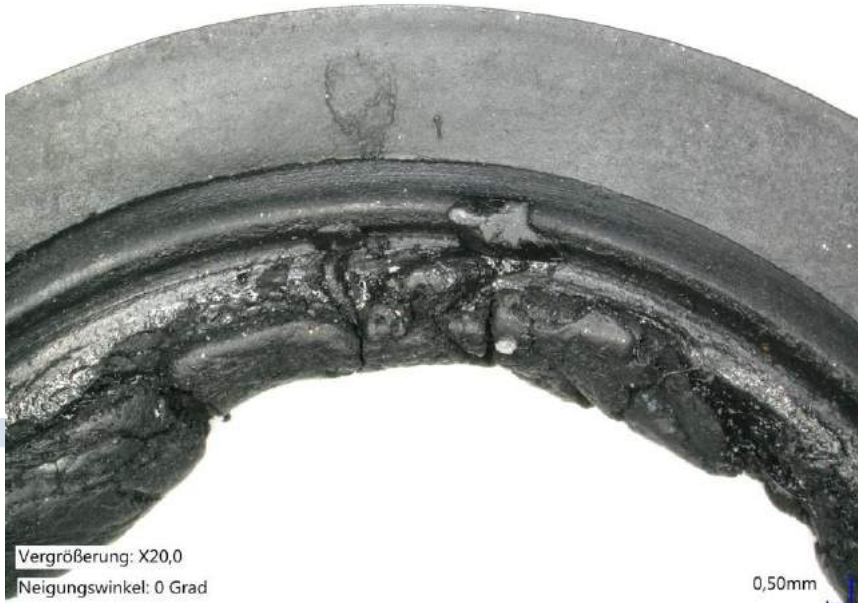
Fig. 4: An elastomer damaged by autoxidation (peroxidically cross-linked EPDM), which has clearly fused areas in the interior of the sealing ring, similar to a thermoplastic or TPE.

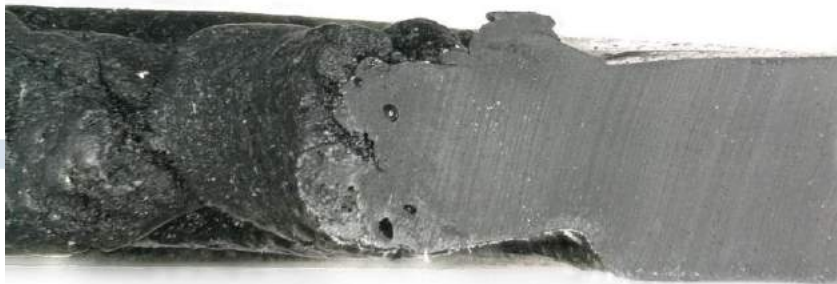
Fig. 5: Seal from Fig. 4 in cross-section: On the left, the damaged area is clearly visible, which had contact with rubber poisons. The area on the right is still completely intact since it was protected by the housing.

Autoxidation can occur after long exposure to heavy metals or fluids containing heavy metals and after higher temperatures on the entire seal. The damage is often found both in the contact area with brass housing parts (in hot water sanitary installations) and on the fluid side (see **Fig. 5**).

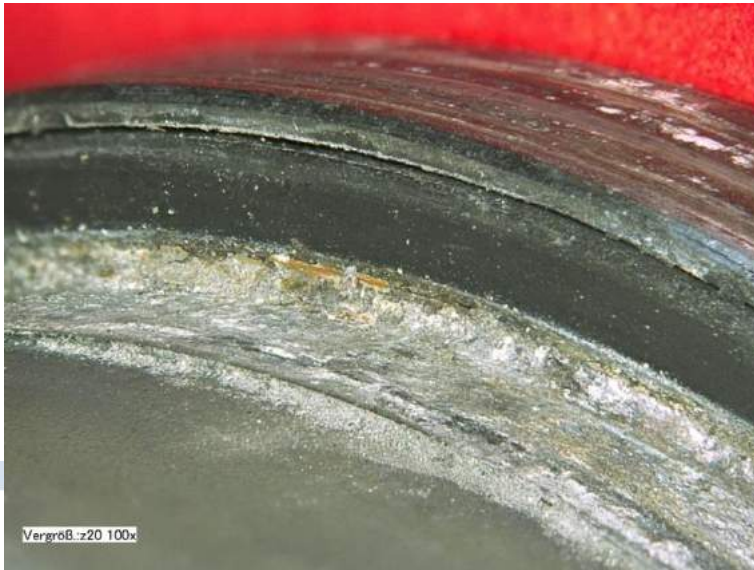
Fig. 6: EPDM O-ring after autoxidation in the installed state, permanently deformed and with a sooty surface

The following three microscope images of one and the same O-ring show that different damage patterns can occur on a seal during autoxidation.

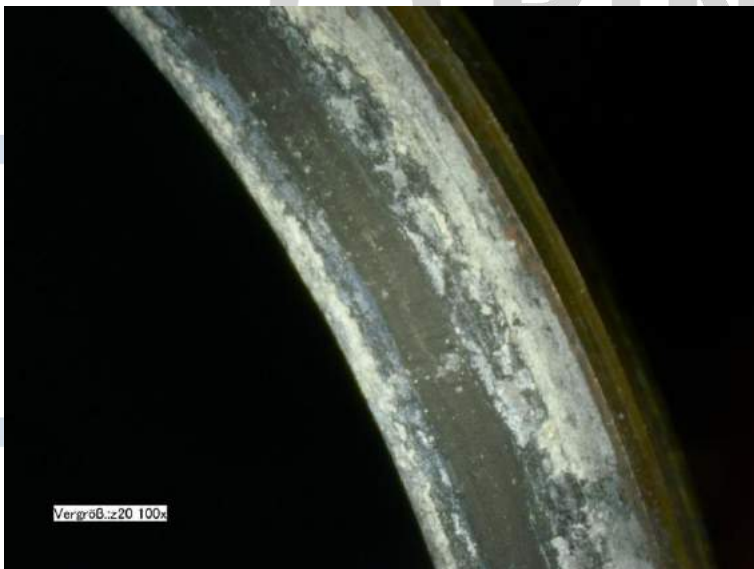
Fig. 7: Opposite surface of the EPDM O-ring from Fig. 6, the white areas are probably lime deposits.

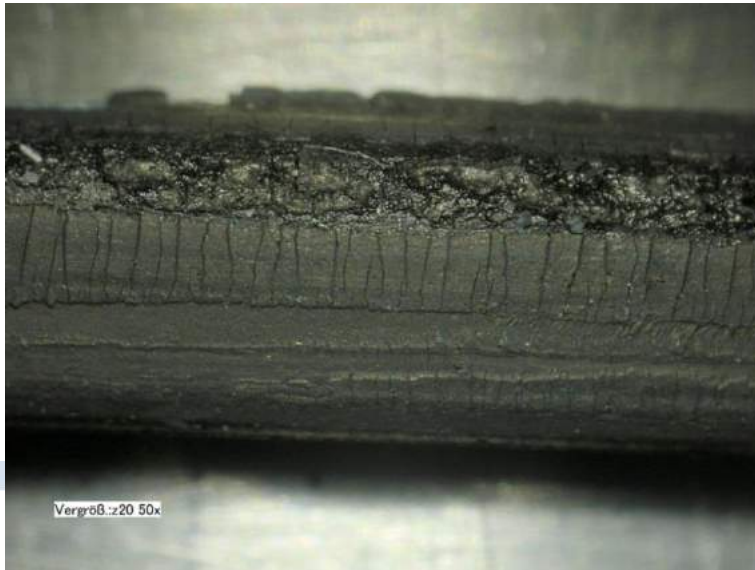
Fig. 8: Top view of removed EPDM O-ring from Fig. 6, the apparently fused areas in the upper area are clearly visible. These were in contact with water, in which the rubber toxin was dissolved. The side with the fine cracks is the contact surface towards the housing.

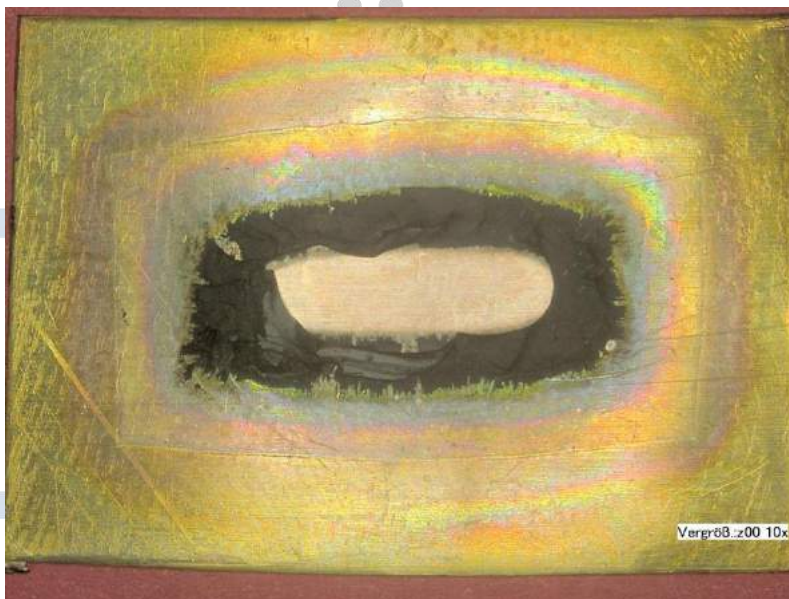
Fig. 9: Remains of a large-area bonding of a test specimen to a copper plate: Such an elastomer is considered susceptible to autoxidation.

The elastomer specimen (finished part or test plate section) is pressed between a glass and copper plate with a pre-defined percentage value and stored in hot air for a certain period of time. If the large-area bonding of the elastomer to the copper plate, as defined in the test instructions, occurs and there is a large deviation in hardness, the elastomer is unsuitable for critical applications with copper contact.
