EXPERT KNOWLEDGE **TEST PROCEDURES** **OF ELASTOMER COMPONENTS**

Integral Approach in Evaluating Elastomer Seal Damage Patterns – The Best Way to the Real Cause of Failure

O-Ring Prüflabor Richter GmbH,
Dipl.-Ing. Bernhard Richter

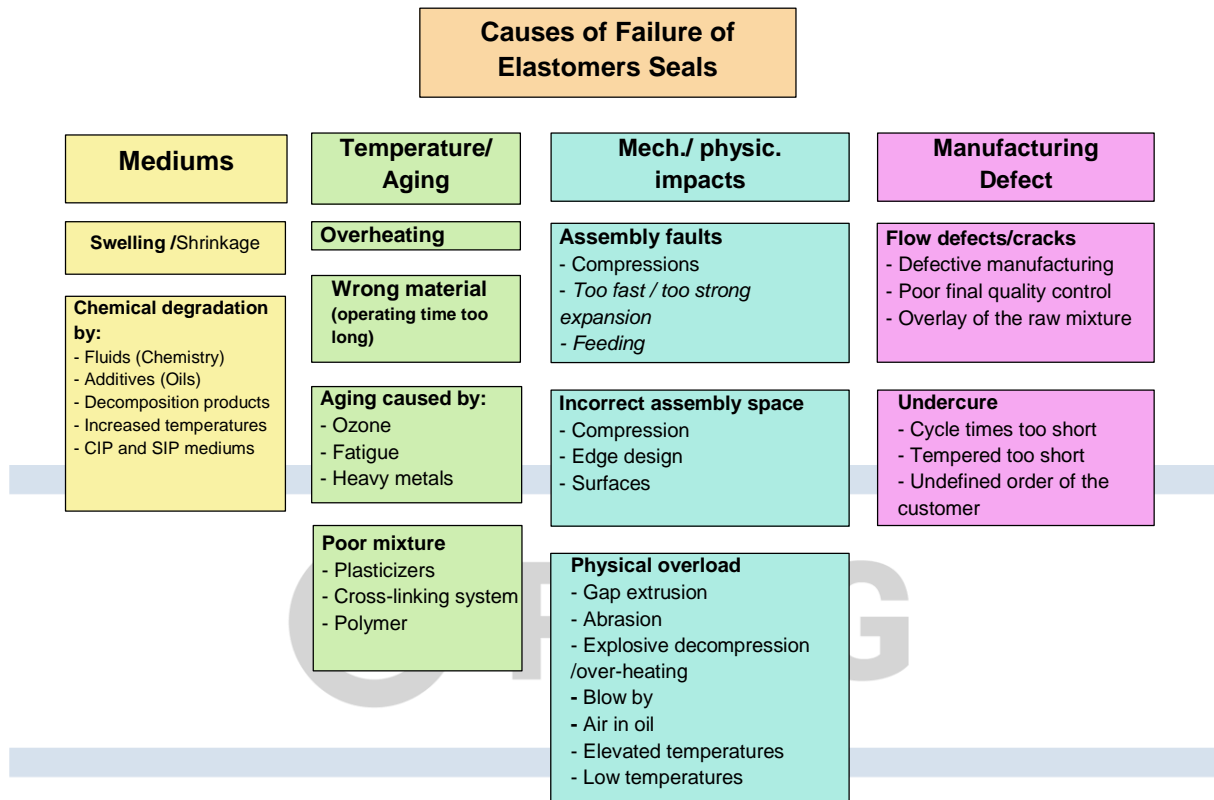
In the subdivision or classification of the damage mechanisms, the subdivision into 4 classes of causes has been useful, see also **Figure 1**:

Figure 1: Classification of the failure causes of elastomer seals
