EXPERT KNOWLEDGE FAILURE ANALYSIS OF ELASTOMER COMPONENTS

O R I N G
PRÜFLABOR
RICHTER

PRÜFLABOR **Chemical Degradation and Swelling** **Destruction of Network Structure by Contact Medium**

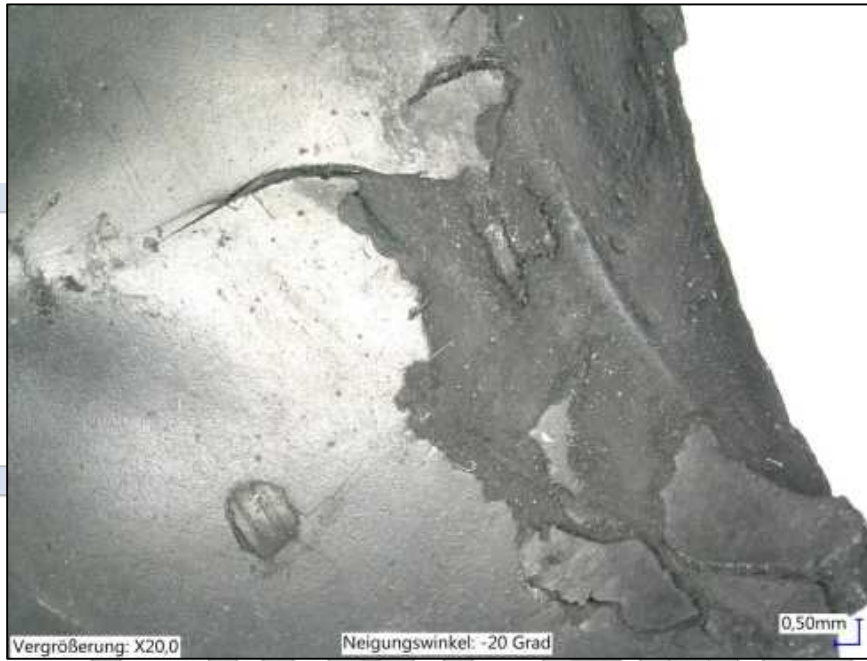
Figure 1: EPDM-seal destroyed by disinfectant

The following points are evidence that a chemical degradation has happened (see **Figures 1-5**):

- Cracks towards the medium, which are visible to the naked eye or only under the microscope in a stretched condition. These can already occur before the material loses its elasticity.
- Strong setting behavior of the seal

- Sticky surface and strong softening (polymer degradation), to some extent also sooty surface
- Hardening and loss of elasticity, i.e. breaking of the seal after light bending or tensile stress

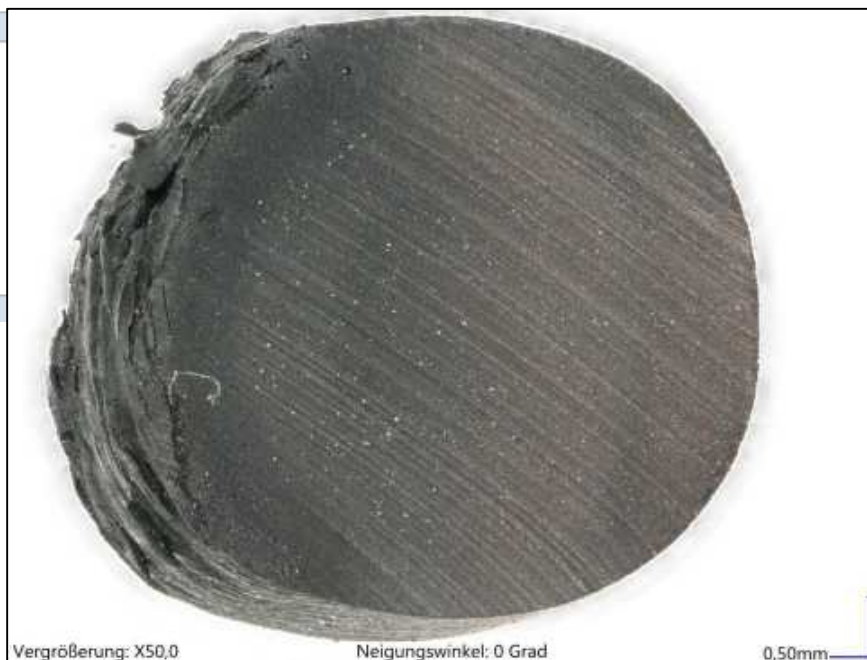
Figure 2: Chemical degradation on FKM-material by an inorganic acid

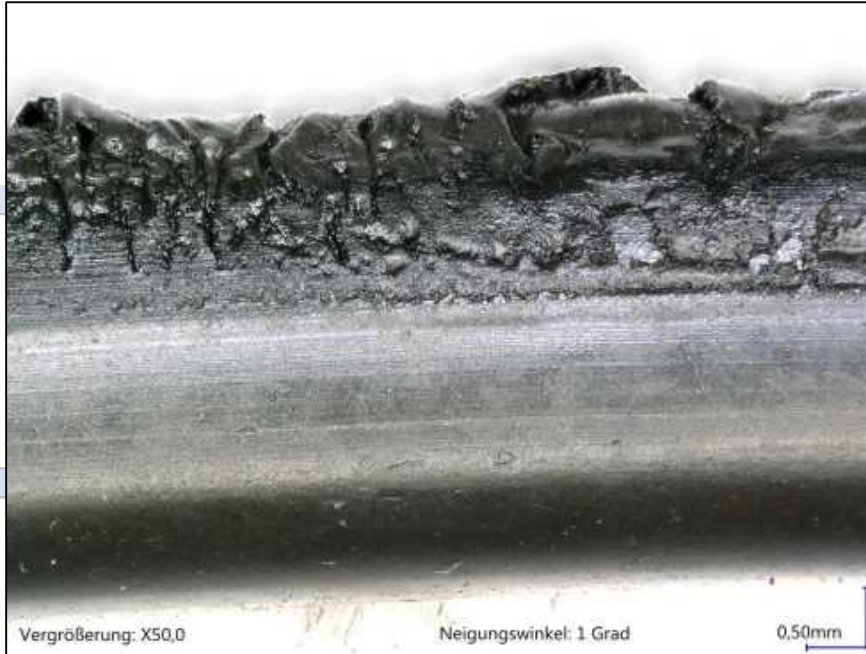
Figure 3: Chemical degradation and swelling with blistering

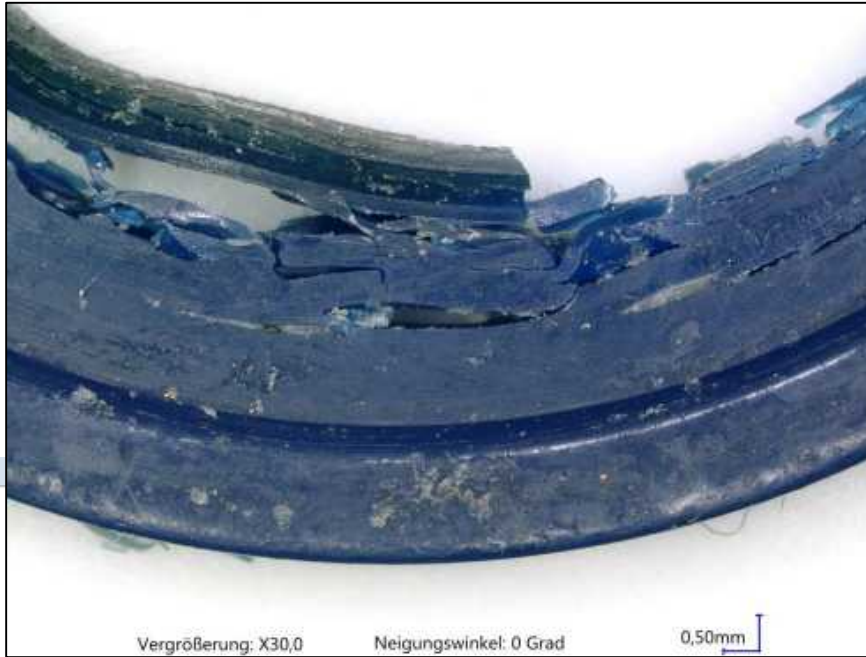
Figure 4: Hydrolysis (= chemical degradation by water) of a poly-urethane seal

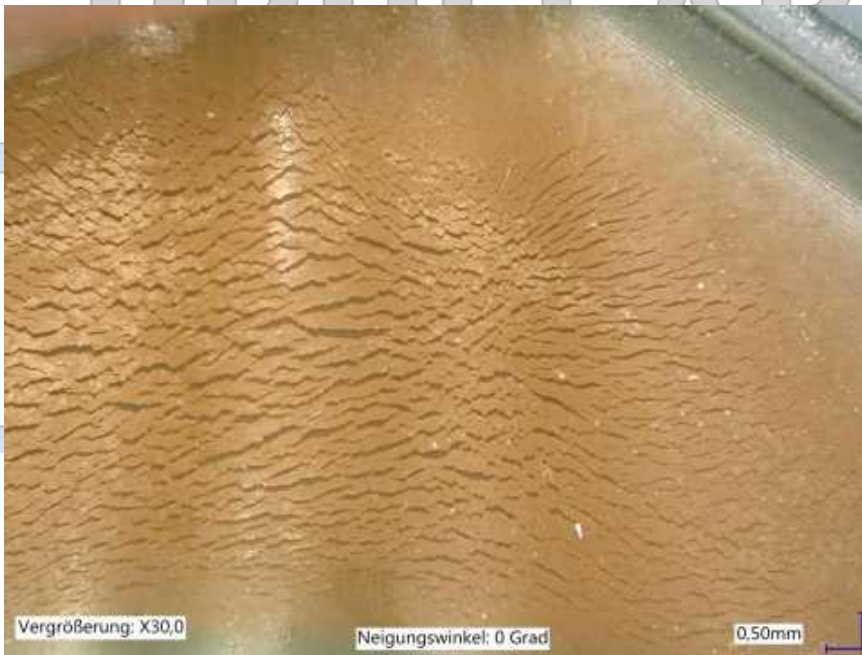
Figure 5: Chemical degradation on FVMQ-membrane probably by blow-by-gas in engine oil

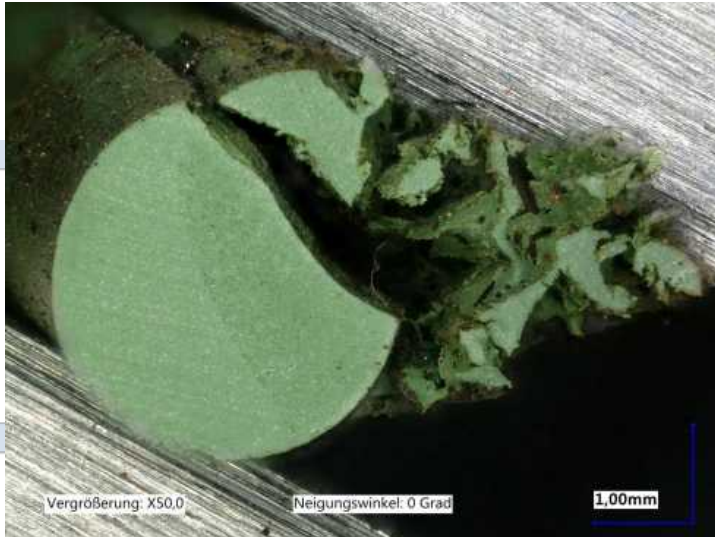
Figure 6: Strong swelling which resulted in shear

The following points are evidence that swelling as cause of failure has taken place (see **Figure 6 and 7**):

- The seal still behaves typically elastic
- Material disruptions or one or two-sided extrusion flash
- Significant increase of volume which usually leads to decrease of density and hardness and increase of the cross-sectional area
- A comparison with a new (unused) seal in a thermogravimetric analysis (TGA) reveals a significantly higher amount of vaporisable respectively extractable components

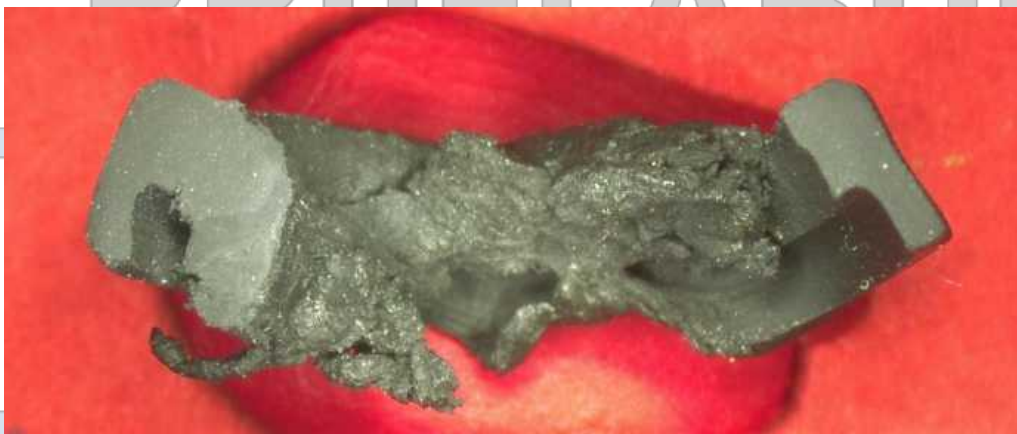
Figure 7: Strongly swelled EPDM-seal after dynamic stress of a lip seal

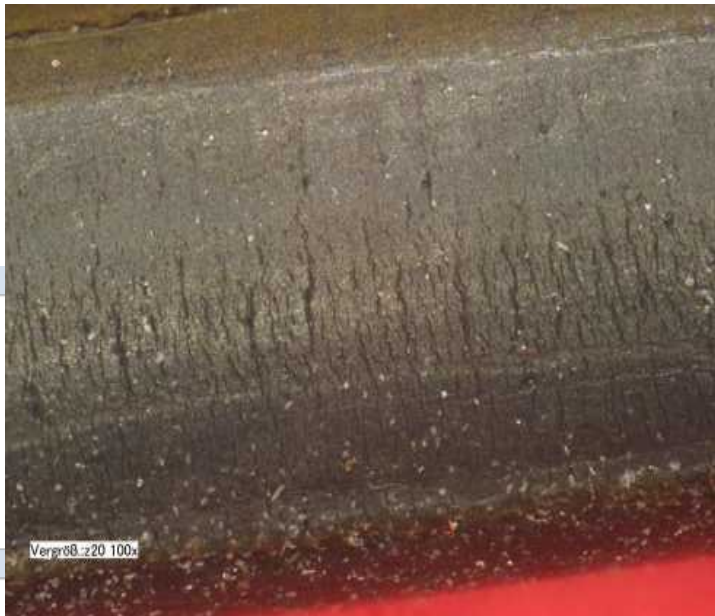
Figure 8: Cracks on the contact surface of an O-ring due to aging through heat and oxygen, made visible through slightly stretched condition

The damage symptoms of aging through heat and oxygen (= thermal overload), see **Figure 8**, are very similar to the damage symptoms of chemical degradation. The actual failure mechanism is the same, namely post curing and chain scission, only now caused by atmospheric oxygen.

The two different failure mechanisms can be distinguished by the fact that chemical degradation damages the seal on the contact side towards the medium whereas aging through heat and oxygen occurs on the air side or in the contact area with the housing.
